**Bathymetry of Mirror Pond
From Newport Bridge to Galveston Bridge**

**Prepared for the
City of Bend**

**MaxDepth Aquatics, Inc.
Bend, OR**

June 2005

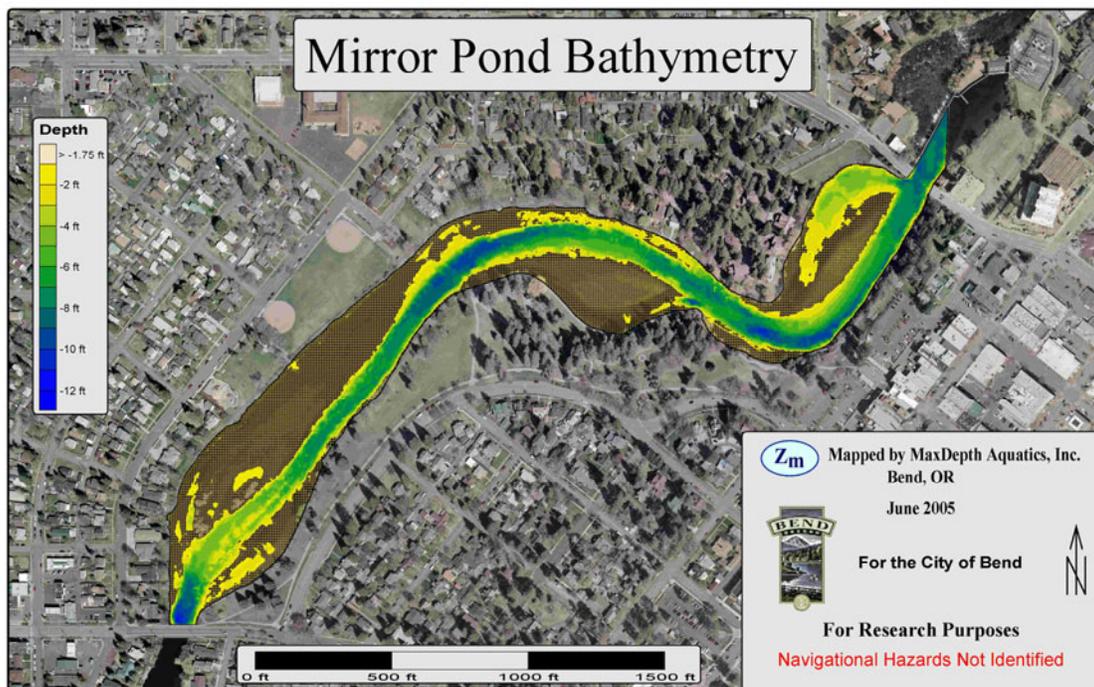
Figure 2. Bathymetric map of Mirror Pond, June 2005. Units are in feet.

The map shows presence of a well-defined channel that extends through the impoundment and extensive areas of shoaling. The deepest areas were located immediately downstream of the Galveston Bridge indicating that current velocities remain sufficiently high to prevent sediment deposition in this area. Substrate classification was not a component of this study. However, echograms of the substrate suggest that a substantial proportion of the accumulated sediment was sand, with fine (silt to mud) in some of the very shallow areas and coarse (gravel to cobble) material in the thalweg and portions of some shorelines (Figure 3).

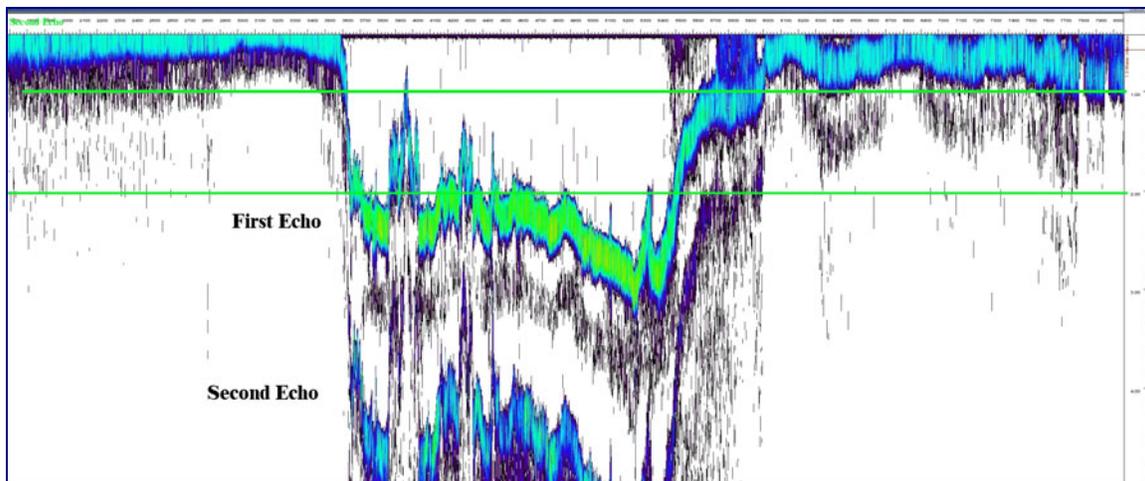
Figure 3. Echogram of a cross-section across Mirror Pond showing the rapid transition into the channel. The second set of echoes below the channel indicates a harder substrate. The two horizontal lines show the 1 m and 2 m depths.
