## Water Resources Department

Re. Dam Inspection for Mirror Pond Dam (Bend Hydro Project, File B-99)

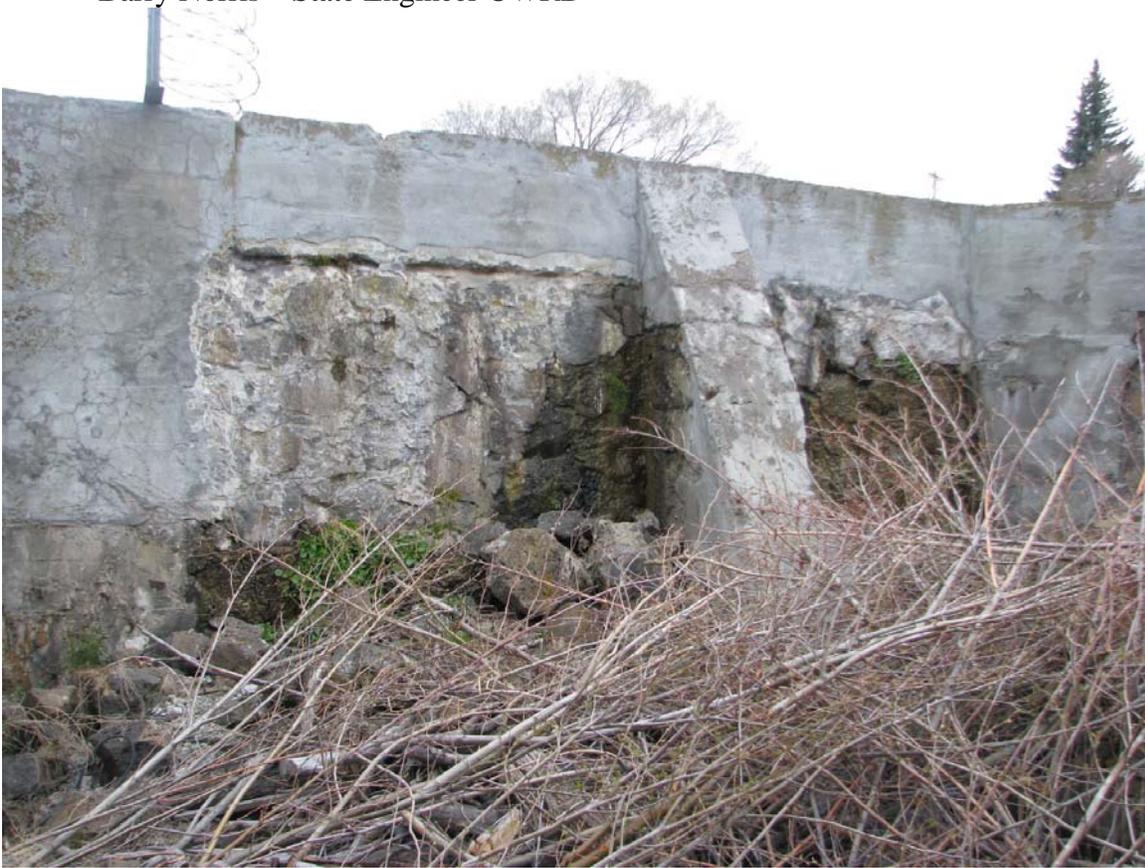
- There was considerable seepage and some spalling along the downstream slope of the dam along the spillway area along the center part of the dam (upstream of island area) (Figure 1).
- The sluice gates in the turbine bays had considerable leakage (Figure 2).
- The stop logs were in generally poor condition.
- Some of the cribs were really pushing a great deal of water out along the left side (spillway portion of the dam and make shift repairs had been done to some) (Figure 3).

Figure 1. Concrete damage upstream of island (note seepage in places).

I would suggest having the damaged concrete examined in greater detail by a concrete expert considering the seepage that is forming there. Some of the cribs along the spillway section are nearing the end of their functional life and should be prioritized and repaired over time. Please keep us in the loop on the current repairs that are going to be done.

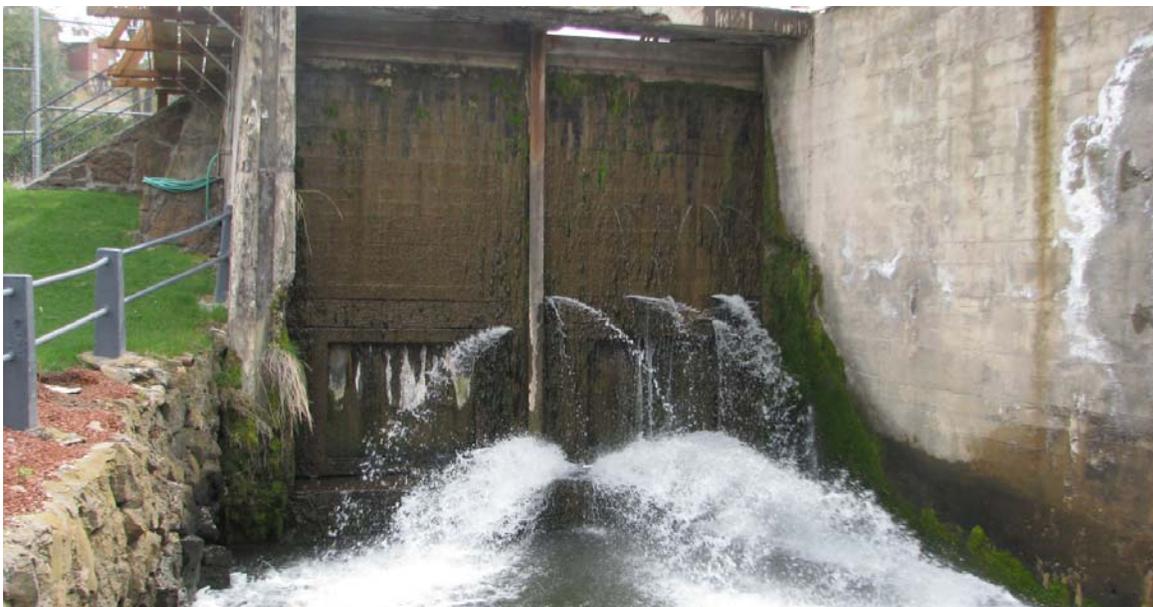
Figure 2. Leakage near turbine area on far right side of dam.

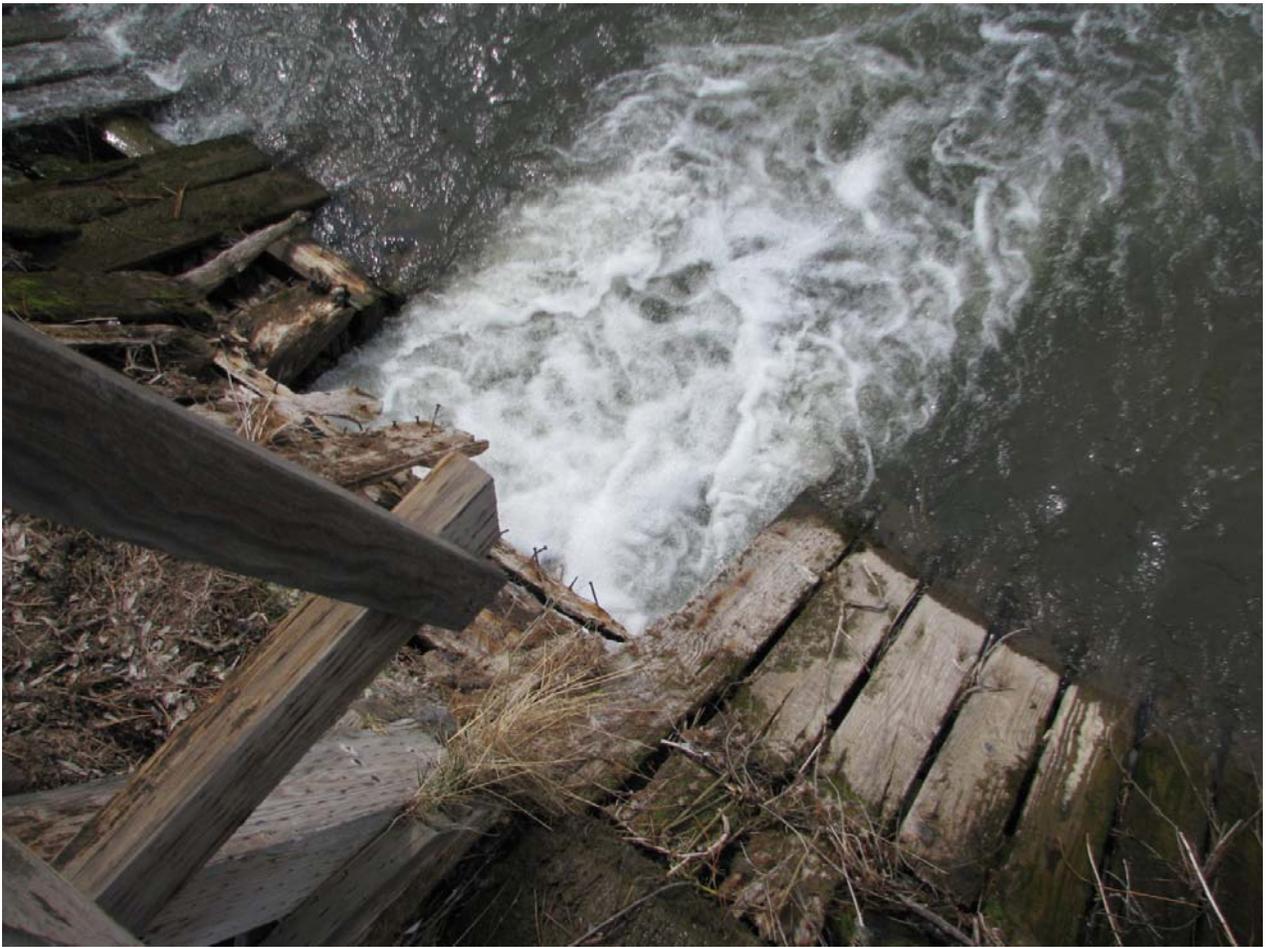
Figure 3. Excessive water moving thru one of the cribs.
